MOSS LANDING POWER PLANT

BRACKETT BOSKER® RAKE REBUILD

Rebuild completed in 2 weeks

Original Brackett Bosker Raking Machine system in operation since 2000

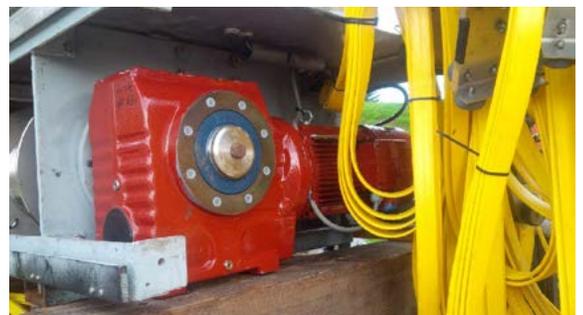
SOME OF THE ITEMS REPLACED DURING THE REBUILD ON SITE

- Hoist assembly (hoist drums and hoist motor reducer)
- Hose reel assembly
- Hydraulic unit
- Trolley drives
- Gripper hoses
- Festoon cable wagons
- Festoon Cable
- Trolley hydraulic fittings/hoses
- Proximity switches
- Mechanical Limit Switches
- Hydraulic drum sprockets
- Nylon transfer gear
